Argentina and France share their most Educational case.

TAVR: the worst complication!

Argentinian Clinical Case. TAVR

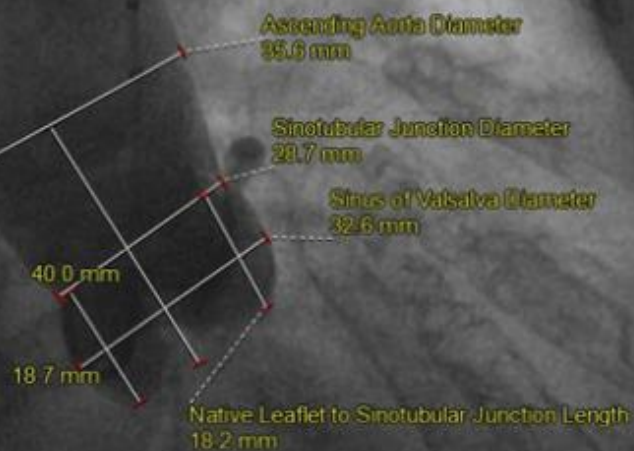
RAO projection

- Multislice computed tomography, Angiography and Doppler echocardiogram were conducted, and severe aortic stenosis with movable aortic valve structures (strands) was revealed.
- TAVR with filters for cerebral protection was programmed.

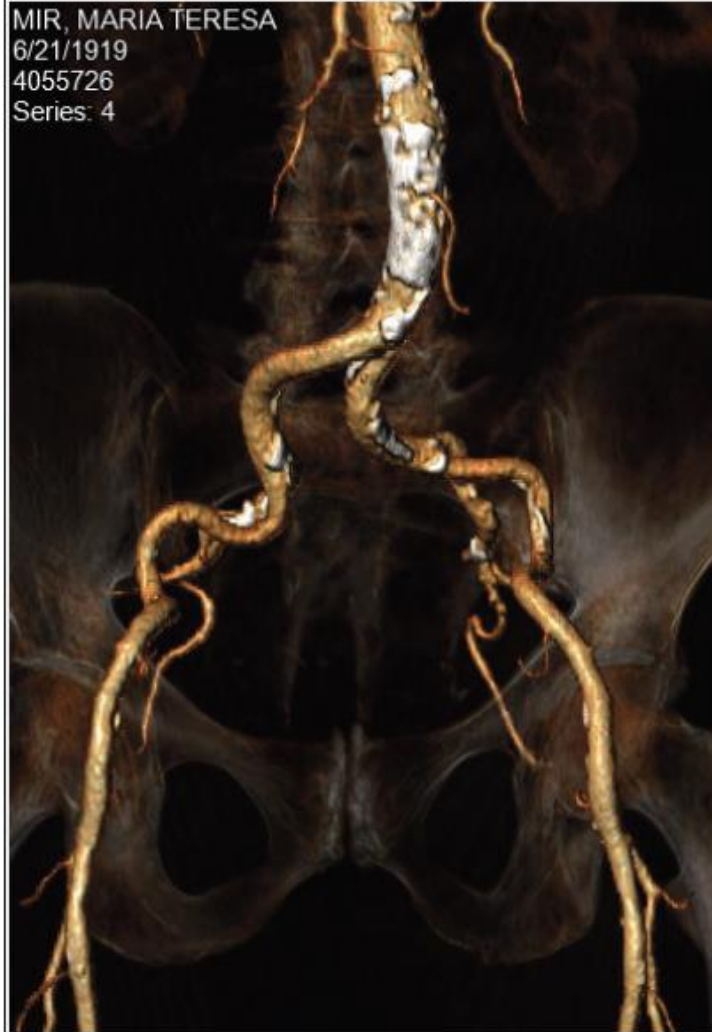
Volume Rendering

Tortuous vessels; limited calcification

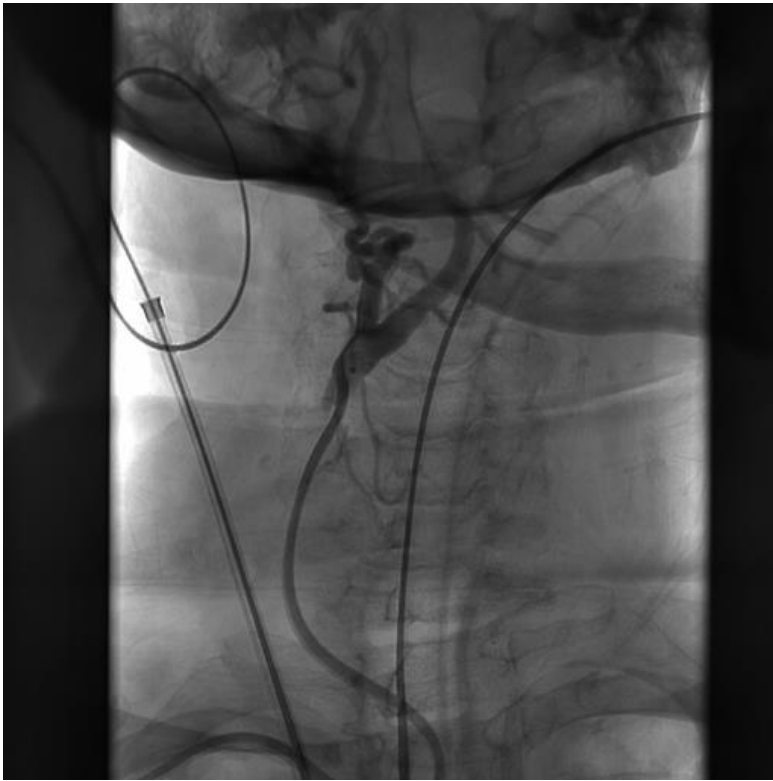
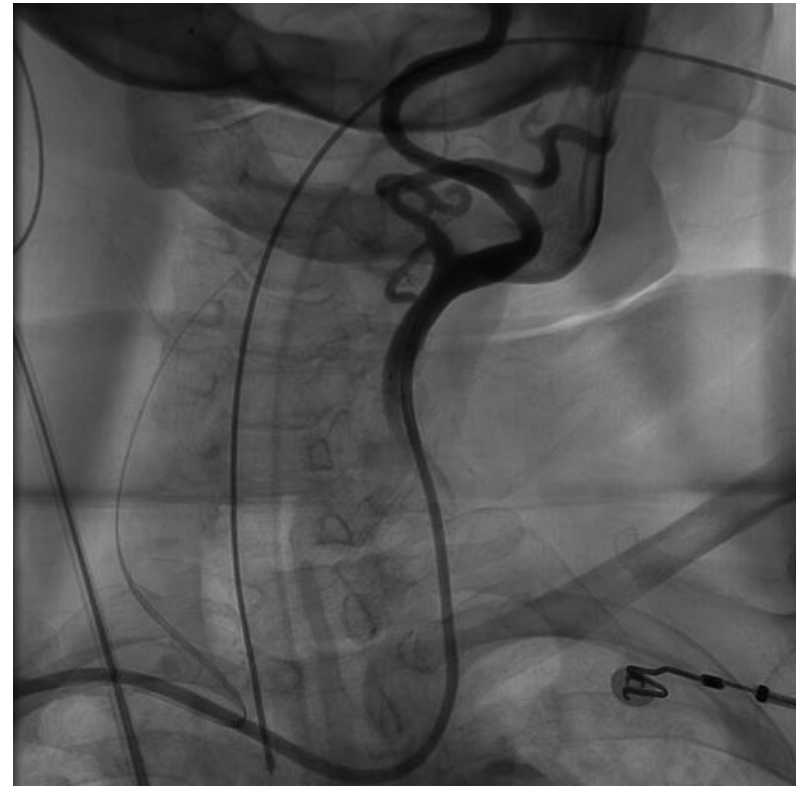
The day of the implant, cerebral protection filters were placed in right and left carotid arteries.

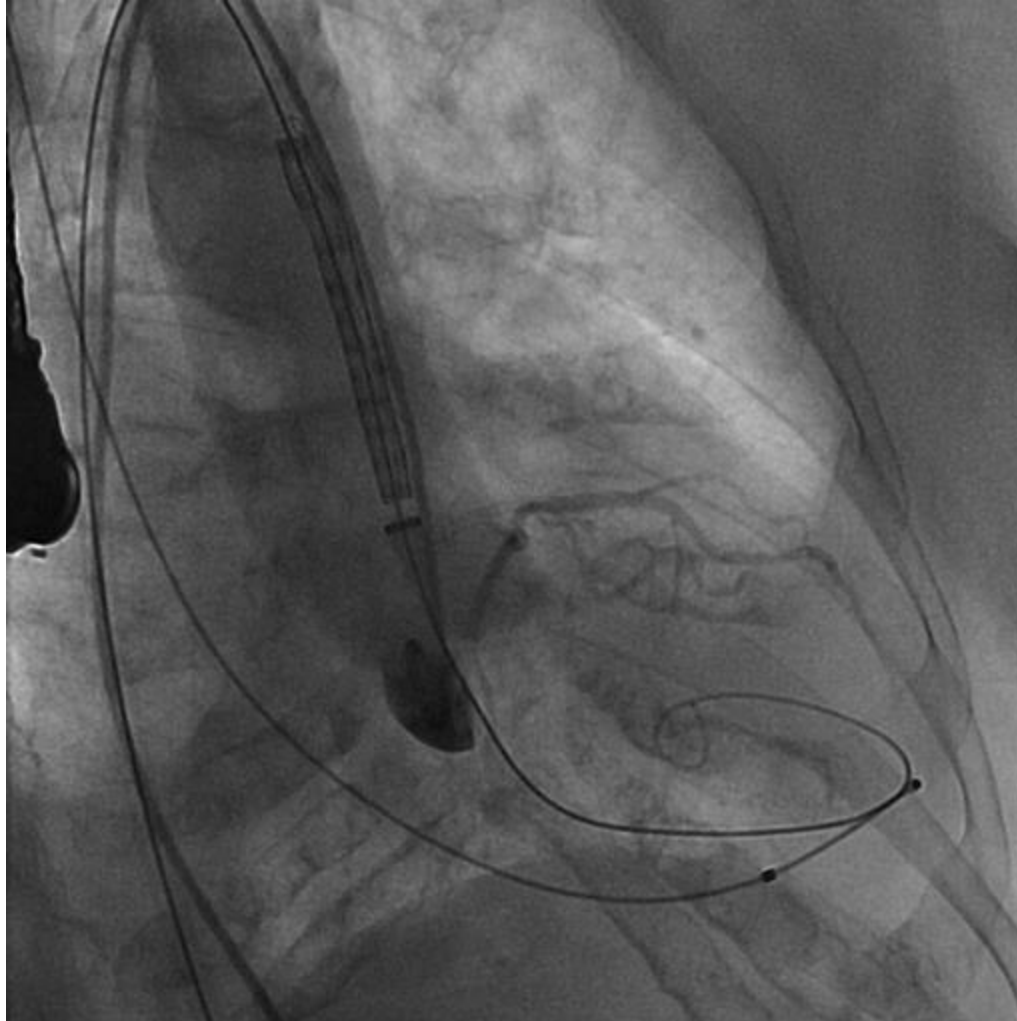
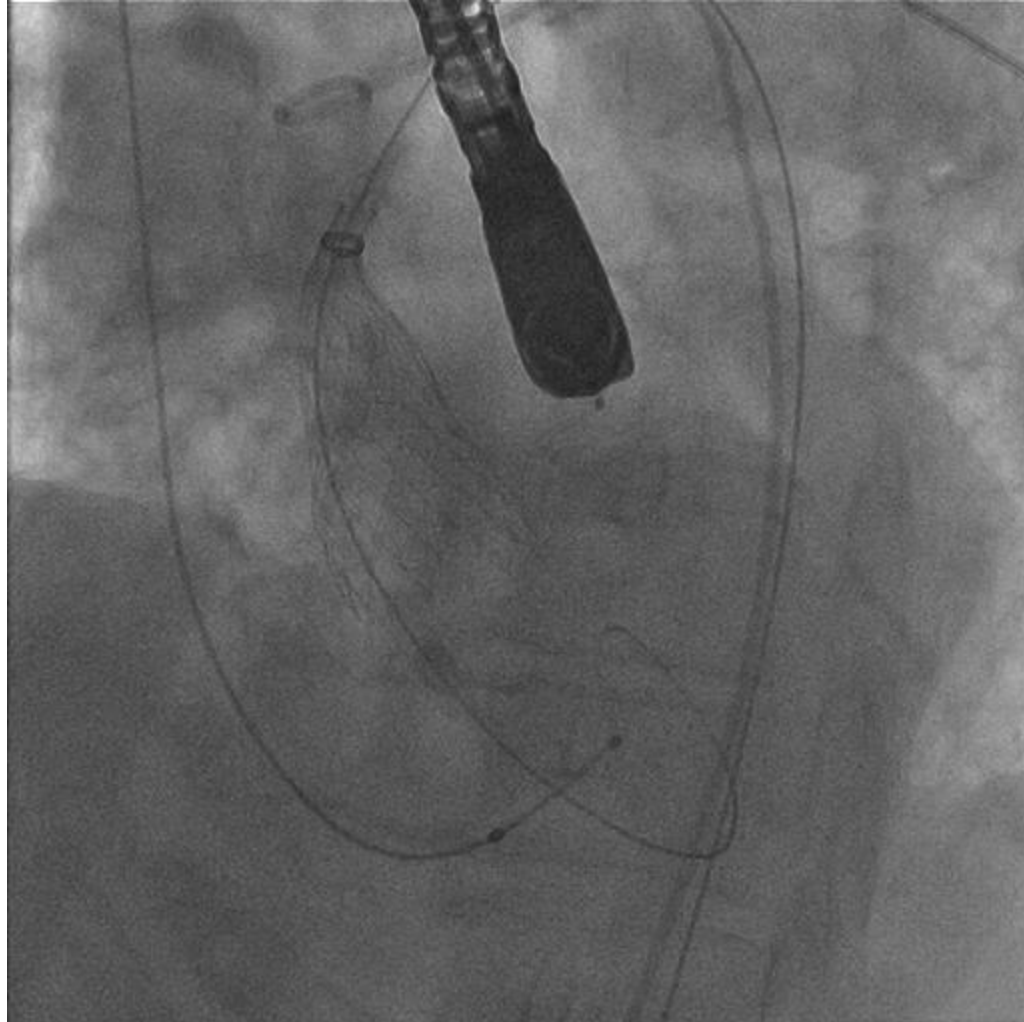
CORE VALVE implant was done without technical complications.
Cerebral protection filters were removed.

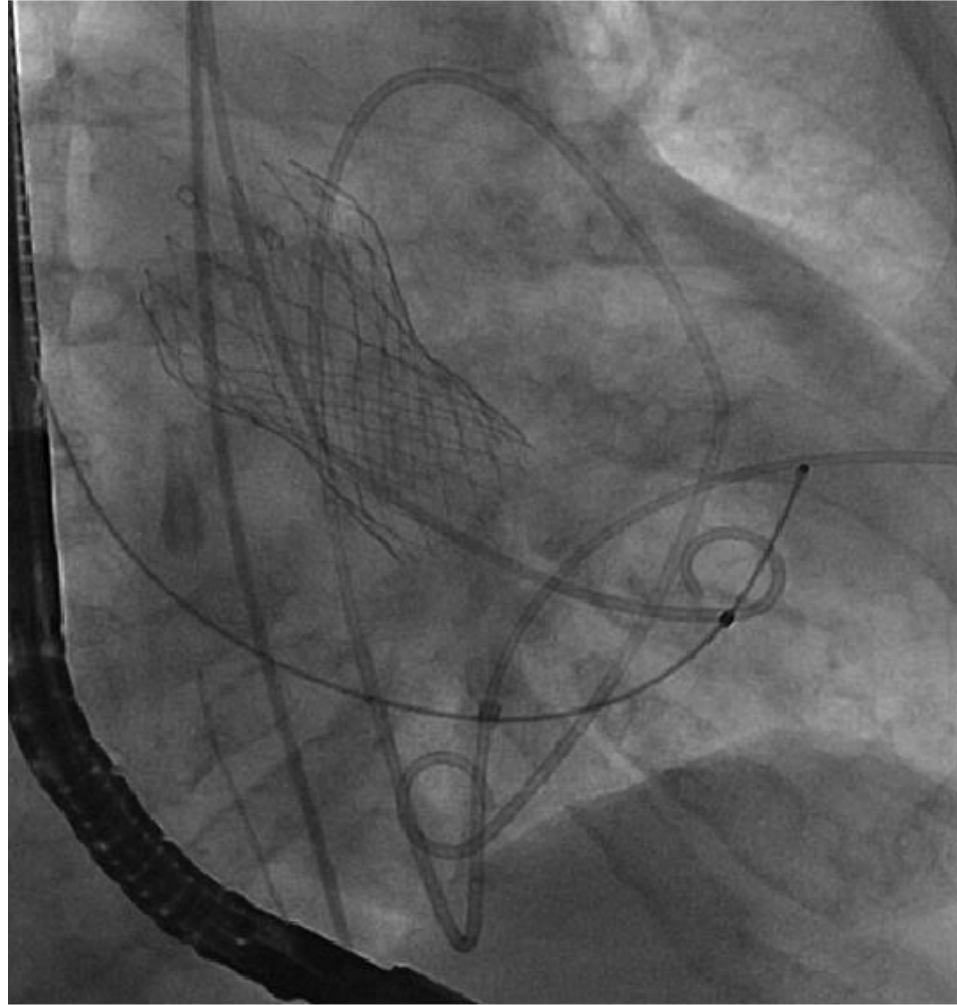
- Minutes after ending the procedure the patient presented severe hypotension and pericardial effusion.
- Therefore a percutaneous pericardial drainage was performed.

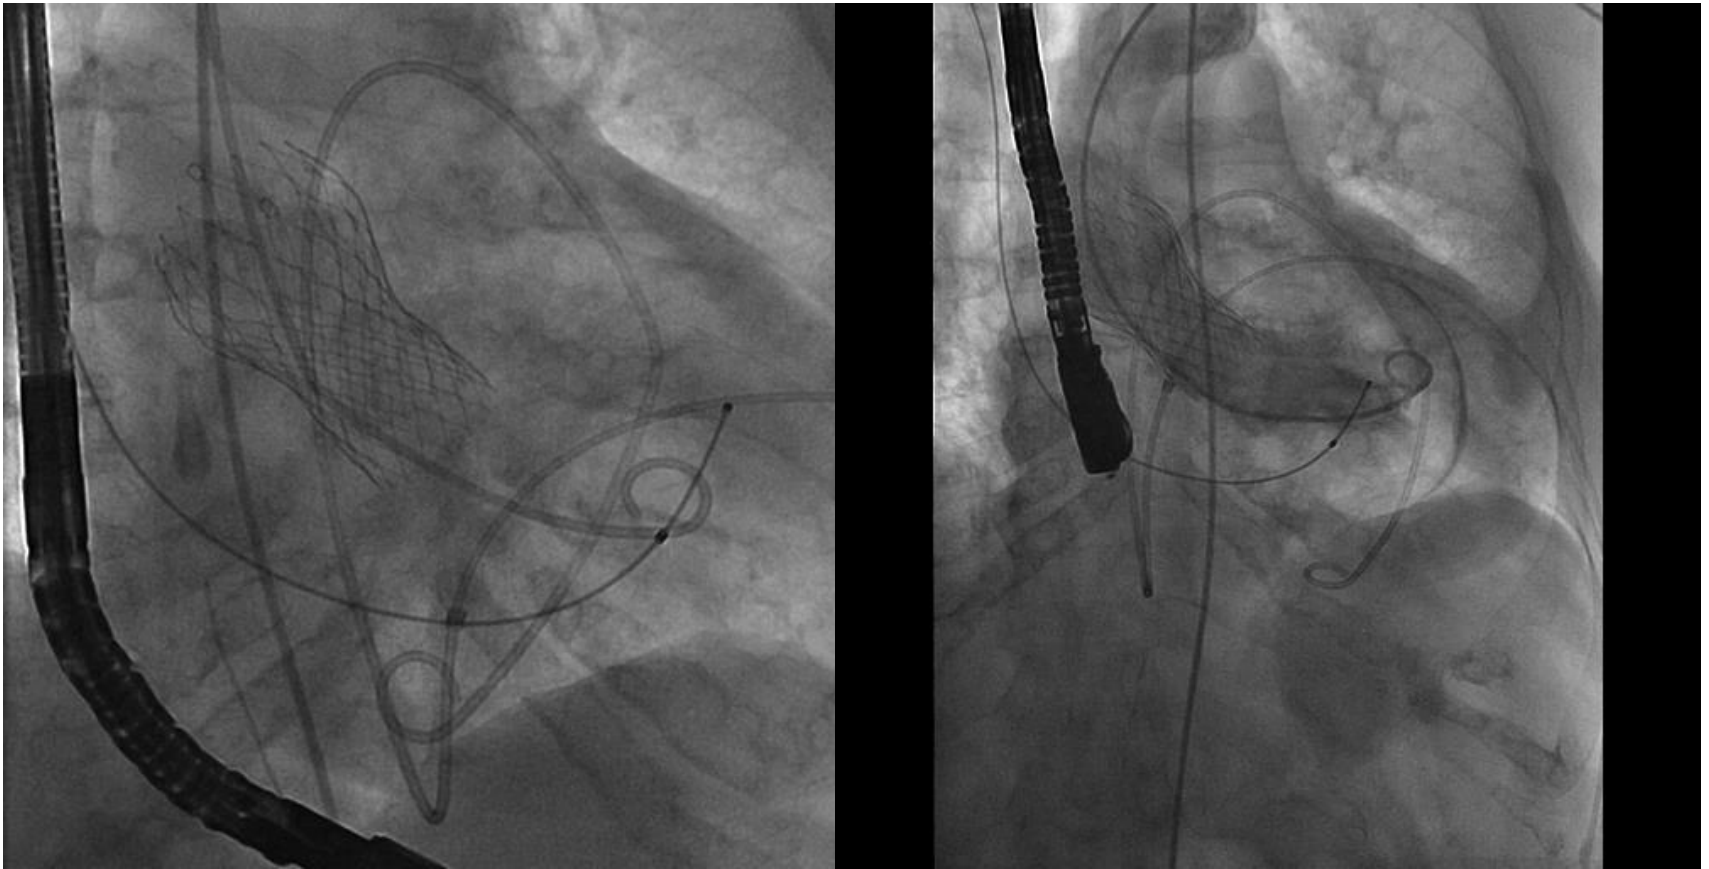
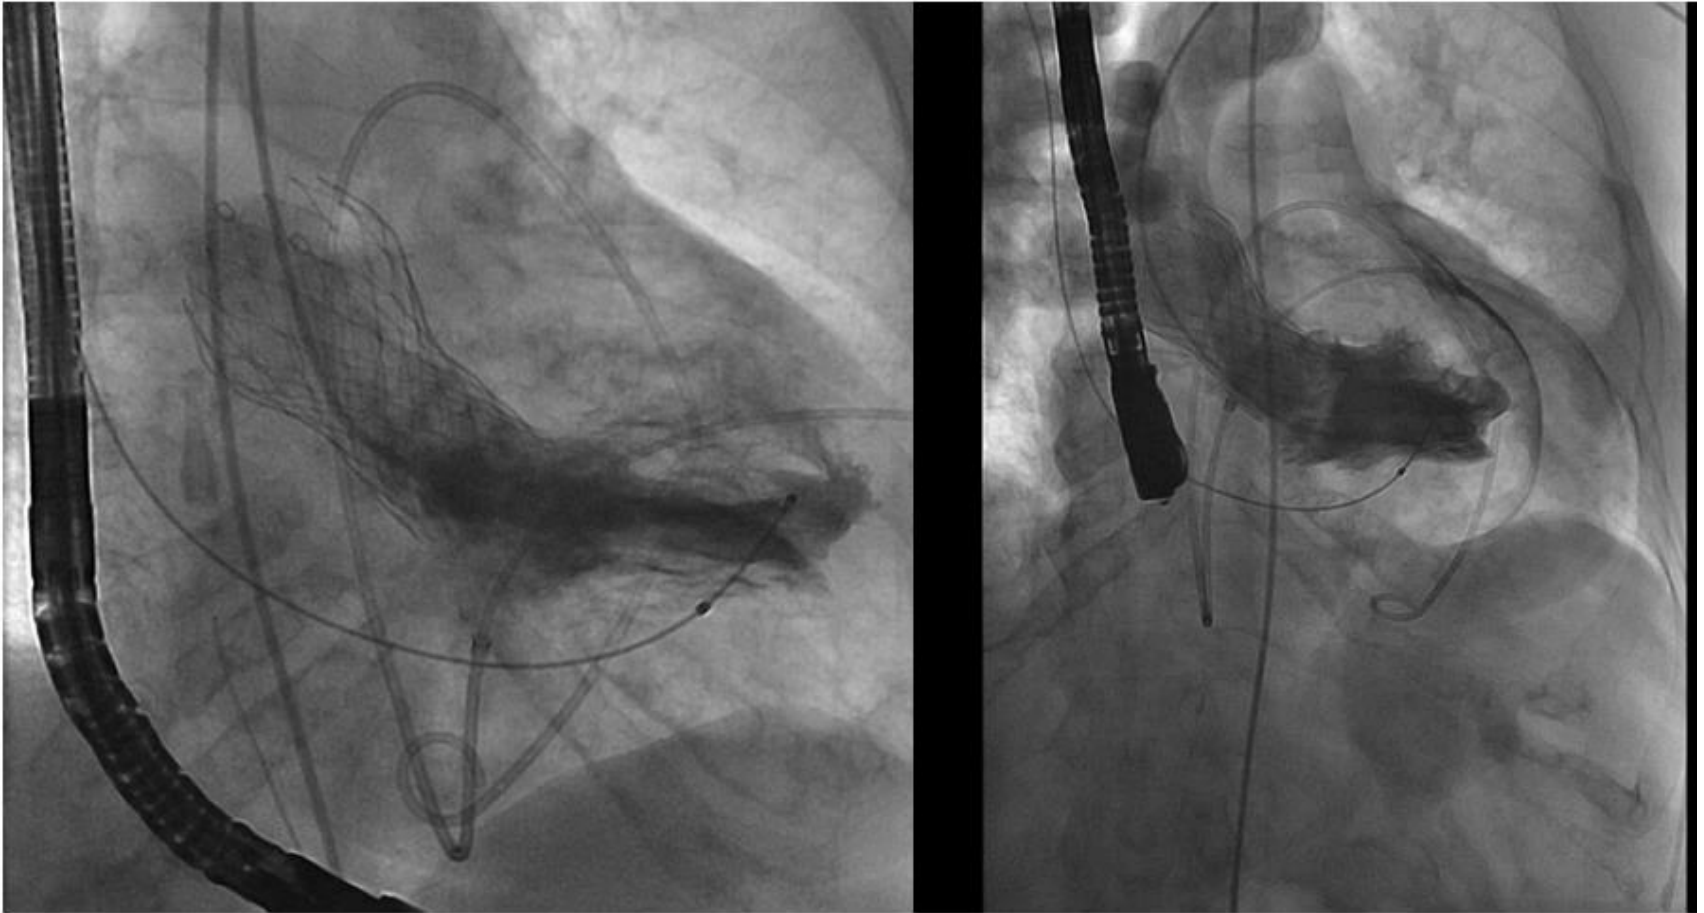
- Given the persistent hemodynamic instability of the patient, it was decided to perform left ventriculography.

The heart was broken, and nothing could be done to save her.
The patient presented cardiac arrest and died.

- 1.- The diagnostic Amplatz catheter, when crossing the valve, hit the ventricular wall.
- 2.- The perforation may have been caused by the Amplatz wire used.
- 3.-The device with the aortic valve may have produced the perforation, but it never crossed the line of the valvular aortic plane.
